Precaution on build-up roof

Henry Liu CPBC 53115 Canada Association of Home and Property Inspectors of BC

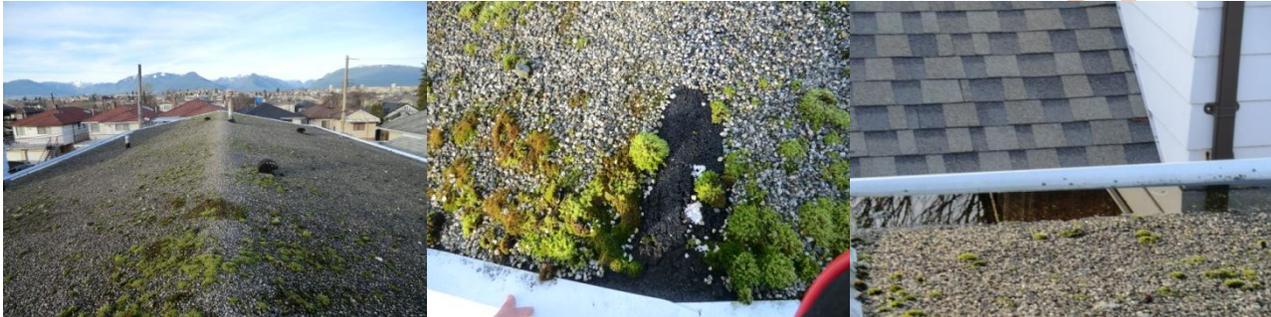
In term of this roof inspection, we found moss but not serious. There is missing of gravel and weathering asphalt to some extent. It looks like the roof replaced about 5 years ago. Water left in gutter which not only added load to roof and but also led to leaking as well as vegetation growing. We suggest cleaning the gutter to make the water drain out; cleaning vegetation by garden rake and moss killer or diluted bleach. Afterwards redistribution gravel with asphalt coating when roof dry completely.

To this kind of roof, the above maintenance is essential at least in every 2 years. The altered temperatures, weathering always cause the erosion and missing of gravel, which results in ponding and exposure of asphalt to UV. These are the reasons to fail the roof prematurely. If we can regularly maintain, it will let the roof last longer. Because the mass and danger of the build-up roof construction, it is costly to reroof.
