## The components on the roof (2)

Henry Liu CPBC 53115 Canada Association of Home and Property Inspectors of BC  
Comfort Home Review based in Surrey

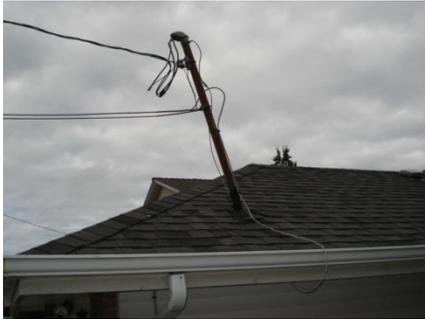
Figure 1

We have to mention the electric service drop which comes from the street pole to the roof or wall, then gets into the interior through conduit or mast. Certainly, there are service laterals which go under the ground. This reduced the wires flying in air and has got more popular in the new construct. We always watch this part when we are doing the inspection. Normally they do not have any issues due to both builder and hydro involved. But I did find the situation like Figure 1, which the post leaned on

the garage roof and caused flashing displaced. It was not a safety hazard but undermined the leaking of the roof, which should be fixed right away. Why did this happen? Because the government has the requirement on the height of power lines over the street & walk way. But the garage is so low that they have to use the post over 5 feet on top of its roof, plus no guy support provided, so the repair has to be on its way.

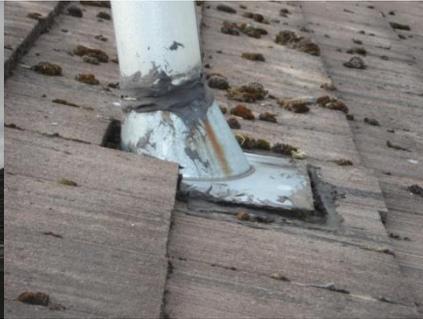
The chimneys are the important part of roof inspection, which functioning to get rid of the exhaust from furnace, water heater and fireplace and look cozy of the home. Ex. Figure 2 the metal vent flashing opened on the roof. When I crawled in the attic, I found water stain at this area. It did have the sign of leaking and have to be fixed right away. Ex figure 3 the deteriorated flashing has to be replaced. There are direct and apparent defects. There are situations tricky that need experience & analysis. Ex. Figure 4 this framed chimney is over 3 feet wide. Theoretically a saddle has to be built in between the roof and the chimney in order to avoid water hold-up, which could also be wicked up into the siding of chimney and cause the moisture damage. Unfortunately, most local chimneys like this did not build the saddle. But we cannot say this is a defect without considering the configuration of the construction. Some wide chimneys are on built close to the ridge or on a small roof. The water drain towards chimneys is not huge to be a problem. Some chimneys increased step and count flashing height. They should be all right to address the scenario.
