The cooperative owner

Henry Liu CPBC 53115 Canada Association of Home and Property Inspectors of BC
Comfort Home Review based in Surrey

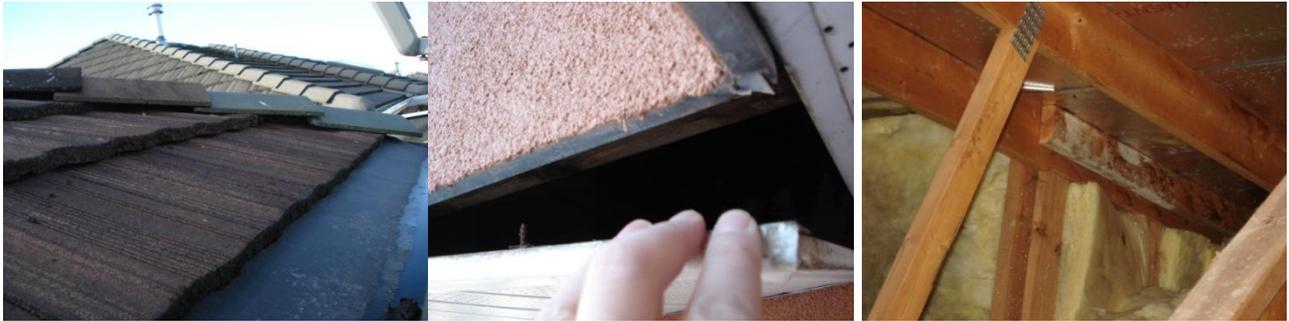
The owner is from South Asia and as a builder who built this house. He is very cooperative & following me during the whole inspection, even helps to hold the ladder when I climb to watch roof at overhang. This makes my job much easier. The roof is not bad, nicely paved concrete tiles, no apparent defect. The gutters are clear and no water retaining and cracks. The flashing of chimney and skylights is positioned well but there is repaired tiles figure 1. Of course this does not mean anything for the repairing on concrete tile is normal. However, there is a loose soffit cover caused my concern ex. Figure 2. It is obvious the hidden rot fascia board which cannot hold the fastener for soffit cover. I confirmed with the owner that it was a leaking he just fixed with the roof before listing this house. Subsequently the water stain was found on the skylight structure when I inspected attic. Again the owner confirmed it was leaking but fixed long time ago. But at this stage I have some idea regarding my puzzle at the beginning.

The gutter leaking was not only in a short period since the badly rot fascia board. Based on the owner, the house was just repaired and renovated before listing, which is normal and understandable, but there was some damage existing for a while including roof and wall which may not get fixed in time and could cause the potential condition. Although in terms of my experience there may not be a major issue, the trivial maintenance is necessary such as fix or replaces the fascia board. This was proved during the following inspection. Especially the kitchen and bath of the 2-bedroom rental unit need lots of work. There is bed in every of 4 bedrooms upstairs. It shows the house accommodating a big family now and all the water, electric and gas facilities are frequently used. Therefore I put it as an essential the immediate maintenance of these facilities (boiler and water tank) as well as wrote all the defects in my report. Even so, due the low care of the existing owner, the buyer should get ready to the cost of fix or replacement of the facilities in the next 2-3 years no matter some of them are still under effective service period theoretically.
