The Receding Wood Siding

Henry Liu CPBC 53115 Canada Association of Home and Property Inspectors of BC

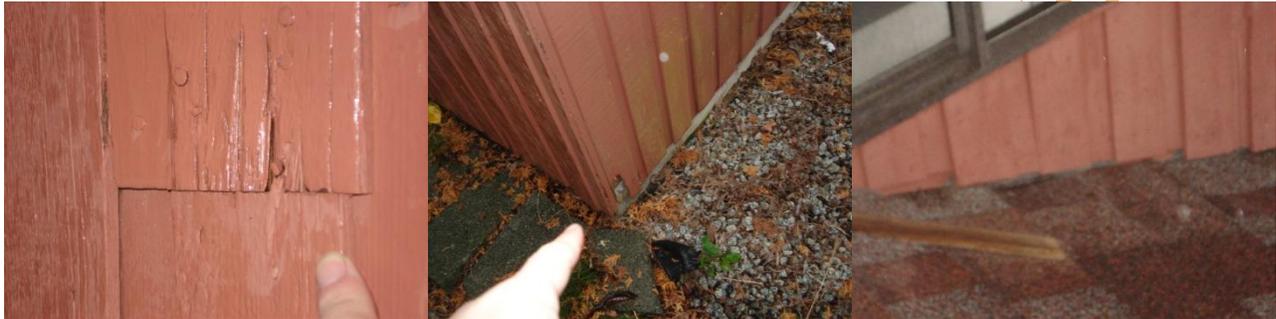
Several days ago, I inspected a 1970s single house with wood siding that is typical. To be fair, the condition is not bad regarding the age of the house but still appears the lack of consideration on building and maintenance. Ex. Figure 1, the new paint cannot cover the rotten end. It would be better to use the whole piece and no butt joints on the vertical applied wood boards. Otherwise, butt joints should be cut on a bevel so the upper board overlaps the lower board and drainage will be by gravity to outside of the joint. Cut ends should be sealed with paint or stain to prevent moisture penetration. Apparently this is not applied on this siding. Although we cannot say this is the cause of this rot, it is a defect for sure. Of course, its position, facing and the fasteners are the entire possible culprit. Again figure 2, the rotten siding end is close to foundation which is the original construction weakness. In order to avoid moisture damage, the siding has to have 6" clearance from the concrete grade or 8" above the soil. Also the approached plants hold the moisture and should be kept away 12" from the siding. Plus the home owner did not paint in time. Generally wood siding is supposed to paint every 5 years or so but there may be earlier failure in the South and West facing. The part under 5 feet should be maintained and fixed regularly due to the above issues and mechanical impact. Ex figure 3, there is no space between the siding and roof underneath, which should have 2" clearance for this wall roof flashing. This is not allowed on roofing. I thought it may be the result of roof replacement from wood shingle to asphalt. Since the plywood has to be added on, the thickness of roof material is more than before. The roofer did not address this flashing accordingly which caused this defect.

Although the stucco, vinyl, metal and fiber cement walls are common on market, there are still lots of wood siding buildings on real estate transaction. It is quite possible to get a better deal even though there is defect of the wood siding. Moreover, I do not suggest replacing the whole wood siding on old buildings. The diligent maintenance & part repair should be good to keep the siding effective & the living space comfort, which does not cost more.
