Key Annual maintenance---Gutter and downspout

Henry Liu CPBC 53115 Canada Association of Home and Property Inspectors of BC

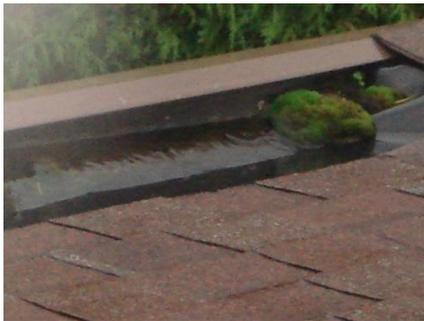
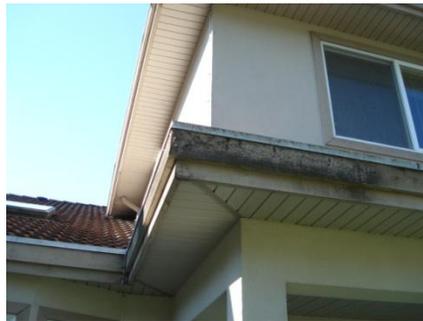
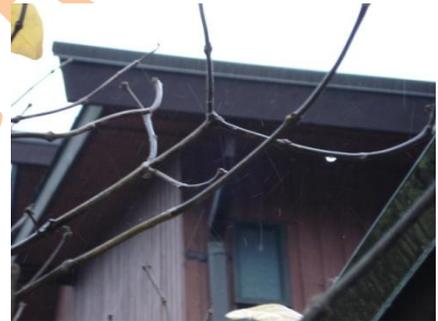
As the figures showing, the gutter was clogged with vegetation and debris, which was common and easy to clean. We suggested the home owner to check and clean gutter before the raining season every year. Otherwise the water running over the side of gutter soaked and deteriorated fascia boards. In the worse scenario, water washed down along the exterior wall and put not only the wall system but the basement/crawl in the risk of water intrusion. Also, the ponding water increased the chance of the roof materials failed of leaking. To the suspended gutter, because it was assembled by different metal parts on site and going through expansion and contraction by weather plus the water load, possibly there were open joints or aged adhesive which caused dripping or leaking. The service was necessary. Due to the age and earth movement, the gutter may deflect from the proper horizontal angle which again caused water ponding and has to be adjusted to drain off.

The downspout mismatched gutter outlet, shown in figure, which was a common condition and had to be fixed. If it was drained on the ground, a splash block should be placed under the downspout outlet to lead the water 4-6' away from the foundation. Many home owners do not like it for the blocking of traffic. We suggest using fabric hose instead. No matter which methods to apply we have to notice that leave the water far away to building is important. Speaking of the underground drain, the cleanliness was import to avoid the debris dropping into downspout and even clogging it. Once it happened on downspouts, the temporary repair is to cut it open and leave it drain on the ground instead. But if the clogs happened at the underground drain tile, the cost of inspection and cleaning of the drain tile was inevitable.
