Electricity--- The heart of the property

Henry Liu CPBC 53115 Canada Association of Home and Property Inspectors of BC

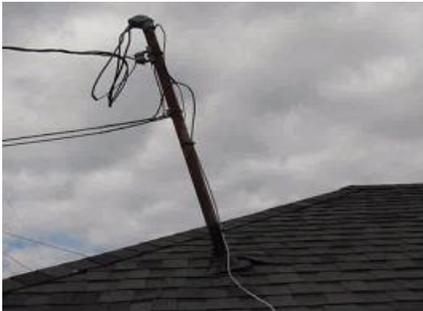
Recently, we got the inspection request from the client who was especially concerned about the house power supply & distribution. Because his friend lived in this property before & told him the breakers are occasionally tripped. Therefore, we paid extra attention to the power service entrance, service panel and wiring. The building has 100 A service entrance which is typical for the house size under 3000 sf with 2 kitchen and 1 dryer. But we noticed that the home owner installed a hot tub in the back yard. In this case, if several high power appliances were turned on at the same time by coincidence, the breaker got tripped was understandable. Actually there is no safety hazard at this moment. The client wants to set up another set of washer and dryer for the suite. If so, the service power has to be upgraded to 125 A which could cost \$1500 to \$2000 mostly for the labor & material of electrician. Certainly, the application to BC Hydro is first.

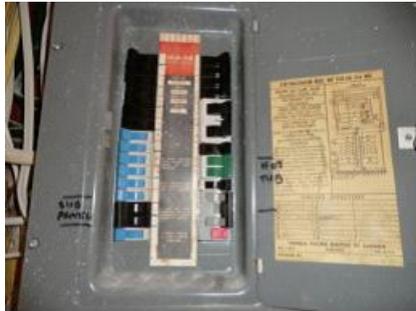
There are 2 common methods of residential power supply in our area. One is the service drop from the street pole. The other is the underground service lateral which is often seen in the newer community. We could not get too much observation on the rear. But normally both of them are taken care by Hydro and seldom fail. However, Figure 1 apparently needs service by home owner in order to avoid power shock, fire and roof leaking. The key inspection is the control panel Figure 2. This is the heart of the building.

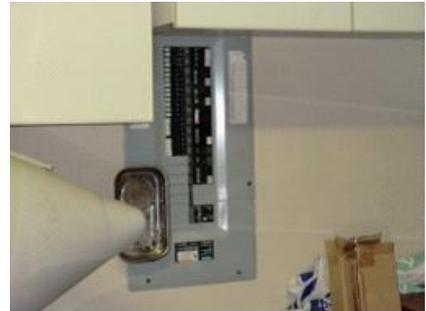
Some conditions we met during the inspection, Figure 3 the main panel was covered which cannot be inspected and operated; Figure 4 there was abandoned live wires in the control box which is not safe. Although it may not cause trouble right away, we suggest hiring licensed electrician to verify.
