A small installation but big effectiveness

Henry Liu CPBC 53115 Canada Association of Home and Property Inspectors of BC

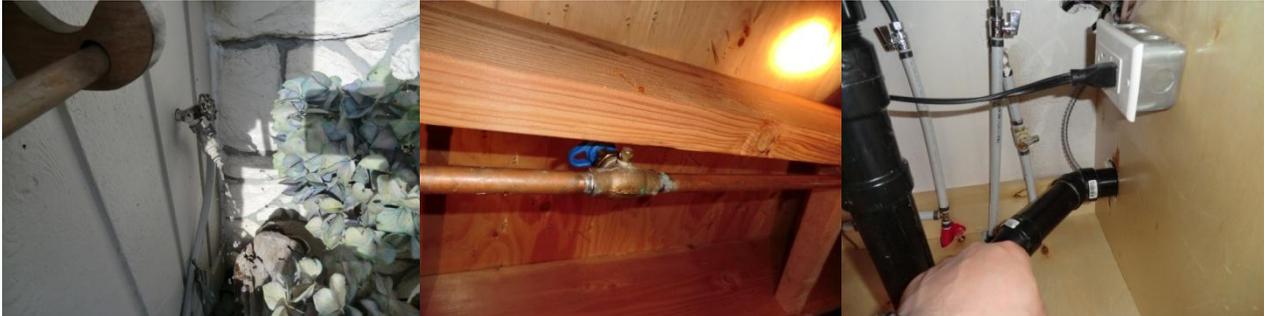
We normally help clients to locate this interior shut-off in buildings but it is not easy due to the different pipe arrangement. As the figure showing, it could be in crawl or under the kitchen, laundry, bath sinks even hiding behind wall. Due to the limited time of inspection & seldom touch on this valve, we do not operate it. Therefore, unless it is apparent, we would like the home owner to explain if this valve is in place. This is not hard to the inhabitants but necessary.

Although the weather is mild in our lower mainland even in winter, it might have several extreme cold days ex. the snow at the end of 2006 and beginning of 2009. Many home exterior hose bibs cracked due to the frost damage. This is not only the cost of replacement but could have further water intrusion for the late discovery, which could be adverse effect on the property. In fact, It only needs the little attention from the homeowner. We normally remind the clients during our inspection. Lots of exterior hose bibs have an interior shut-off valve which is exactly the same as the bath & kitchen tabs shut-off under the sink. Once something wrong with taps which need fix or replacement, we only need shut off this valve rather than go to turn off the main water shut-off for the building to cut off the whole water supply. The first function of the interior shut-off for hose bib is to avoid frost damage in harsh winter. The operation is to shut off the interior valve before winter and open the exterior bib to discharge stagnant water. In the coming spring when the weather is getting warm to open the interior shut-off and as the water drains out from bib we can close it. The hose bib is back to the normal function. However, not every building has the interior shut-off. In order to go through the winter safely, to wrap this bib with insulation even thick cloth is an option. Many stores have the expanded Polystyrene moulded cover for it. Also, some bibs with anti-frost sign are free of worry about frost.
