Poly-B worry?

Henry Liu CPBC 53115 Canada Association of Home and Property Inspectors of BC

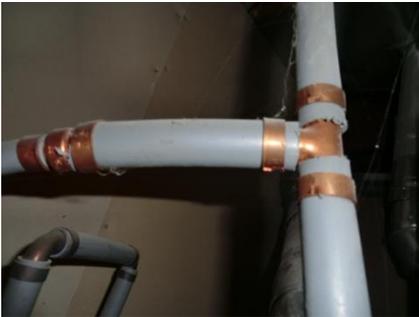
It was the same as other plastic pipes ex. Polyethylene, Pex and PVC, Poly-B was widely used on the city water

supply & building interior pipes. Because its good flexibility is only next to Polyethylene, it can be used for hot water line as well. Also for its flexibility I personally believed it was more suitable on our local buildings which are mostly light wood structure. First this foundation was not built as much as concrete requirement. In addition, we are on the earth of active slab, which caused movement all the time. Although

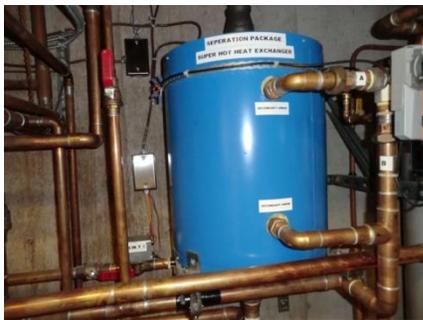
Poly-B was also applied as heating pipe buried under flooring or connected to baseboards. People always mixed up this boiler heating pipe with hot water pipe for sinks & showers. Actually, Poly-B which was used for room heating should be paid attention to. The previous poly-B pipe was not air tight and did not have an air barrier for oxygen. Therefore the oxygen could immerse into the heating circulation, which could cause heat exchange rusty & leaking leading the boiler failure prematurely. In order to keep the boiler life expectancy, the solutions could be through adding chemicals to reduce corrosion or setting up an auxiliary heat exchanger (figure) which can be scarified to avoid the cost of
