Well kept property landscape first

Henry Liu CPBC 53115 Canada Association of Home and Property Inspectors of BC

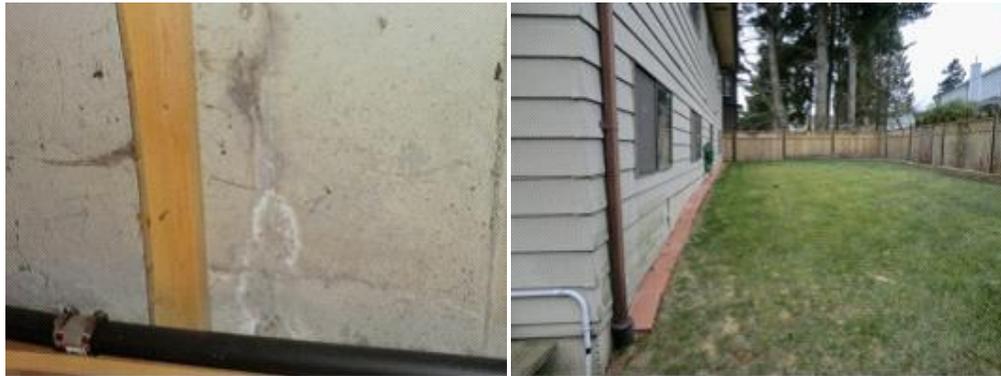
Recently, I inspected a 30 year's old detached house in South Surrey. After addressed results to the client, the agent asked me if there were any major issues. I said no. The client was not happy with my answer and believed the shrinkage crack, efflorescence and moisture stain (Figure 1) which we found on the foundation wall were critical. We totally understood the thought and initiative of the buyer. But to respect and be responsible to the building we cannot say major defects for the age of the building which cannot be evaluated by new building code unless there were

existing issues jeopardizing the safety of inhabitants and the stability of the building.

However, we again explained to the client the condition of the foundation. What we had seen is concrete shrinkage crack normally shown on foundation wall especially on old buildings, which should not

have any effects on the structure stability. The visible condition on this 30 year building was acceptable. But in order to avoid moisture intrusion, we suggest reconditioning the exterior grade slope to make sure the ground water flow away from building foundation. Also we found big-O underground drain tile around building foundation, which is not applicable on new construction for their inherent defects. Therefore monitoring the drainage is essential and cleaning or replacing drain tile if necessary. These are the methods to keep the foundation not susceptible to moisture damage. Of course, the crack can be filled with some repairing stuff to reduce the water entrance but this is only a temporary fix and won't last long.

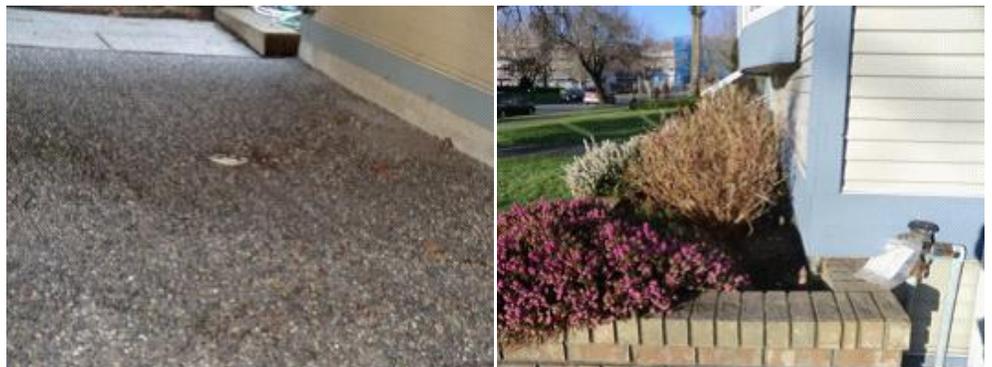
be built accordingly. A lot of buildings have the negative grade slope towards them. In this case the area drain (Figure 3) and French drain are the only way to keep the water flow away. At this stage, it is necessary to keep the drain clear without any clog.

Consequently, we remind homeowners taking care of the lot grade and landscape. We prefer the ground water can flow away from the building foundation by gravity.
