## Be cautious on negative grade

Henry Liu CPBC 53115 Canada Association of Home and Property Inspectors of BC

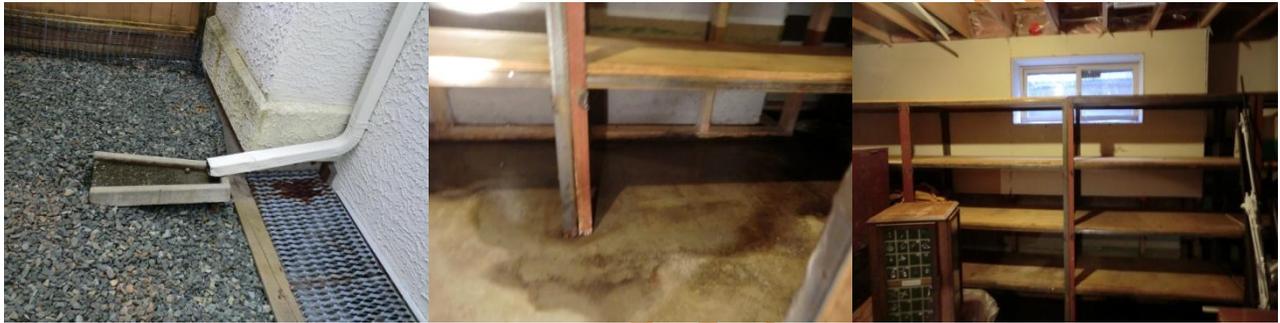
This scenario happened on my inspection for a client from Poland several months ago. This was a 17 years old over 3,000 sf 2-story detached house with finished basement. It was designed and built by German delicate workmanship. At the first glance, I found the negative grade from the neighbour side. The rust on the basement window cover is the sign of drainage problem. When I inspected the basement, there was standing water along the exterior wall. The seller happened to pick up stuff and asked me what was going on at that moment. I told her there was water intrusion in the basement. She was surprised and said she spilt water this morning. Well, it was not unusual that the home owner did not really know the condition of the property but trying to hide something was different. To be responsible for the seller and buyer I double checked leaking sign which the water crept along and intermittently at the wall footing. Also the stain appeared various times of intrusion on the floor from wall to inside, which verified my judgement. The culprit should be the negative grade, plus the failed moisture barrier and cracks on the concrete foundation which the last 2 were quite common on every building. But once the grade can drain the water away, those should not be too much worry. In addition, the perimeter drain could have trouble too but few chances on this age building.

Once this kind of issues was popped up, the extensive repair and big cost were on the way. Therefore, this section is always critical in our inspection.
