The widely used Stucco

Henry Liu CPBC 53115 Canada Association of Home and Property Inspectors of BC

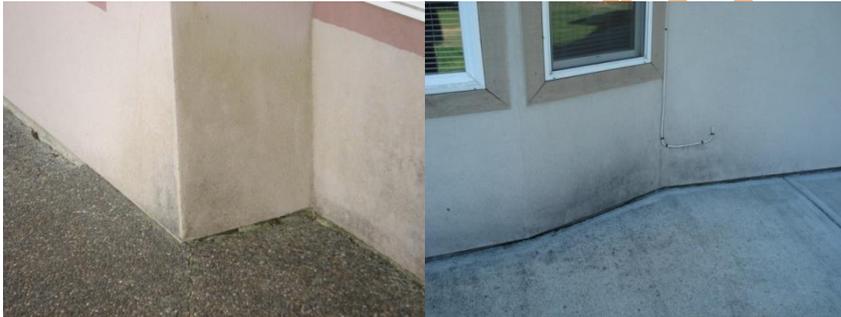
The most condition of conventional stucco wall is the crack. It normally showed up in my inspections, which is most often located at the sides of doors or windows, the corner of walls. This is caused by the stress

concentration of different adjacent materials plus the thermal expansion and uneven settlement. Normally this is not a structure concern and no leakage worry. It could be fixed by paint. Once the crack is over 1/8", it has to be filled up first then painted by breathable coating. But if there is more than one crack in the same direction in one area, the structure engineer should get involved. Ex. Figure 2, the wall contacted walk way. It should be a minimum 6" clearance to avoid the moisture wicking up which could cause moisture damage to structure and moss grown up. In case of the building settlement, there may be a negative grade towards the wall foundation. This would be the bad scenario. Also any plant encroaching to the siding should be removed to keep the siding dry fast. In addition, the flashing and gutter of wall and roof should be well addressed. It is not often seen but a good solution to put a kick-out in place to prevent a large amount of water rundown from damaging the inside of the wall.
