To avoid ice damming in the snow days

Henry Liu CPBC 53115 Canada Association of Home and Property Inspectors of BC
Comfort Home Review

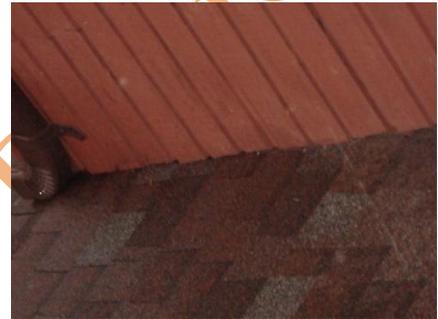
At this moment, the writer brought up an inspection that is finished a couple of days ago. The roof has just been replaced and appeared in good condition. But the wall and roof flashing caused my attention. The wood siding is just on the asphalt shingle as figure showed. There is no cutting space as preferred minimum 2" on the flashing between the siding and the roof which is important to drain the water and stop moisture holding at the wall and roof intersection. If snow accumulated, the melted water might be hold here even wicked up behind the siding. Both leaking and frost/thaw damage are quite possible.

Then how can we prevent ice damming? First the effectiveness of the insulation is the key. If not enough, the owner should add more. Second the ventilation of the attic is necessary. Also, a piece of 30" wide eave protection could be installed under the shingle to avoid leaking. Certainly, this can only be done when replace the roof. In addition, the heating cable could be mounted along the eave to have the snow melted in time. But this is not really practical, because it has to be started before the snow fall otherwise the result might get worse.
