The inspection of Doors & Windows

Henry Liu CPBC 53115 Canada Association of Home and Property Inspectors of BC

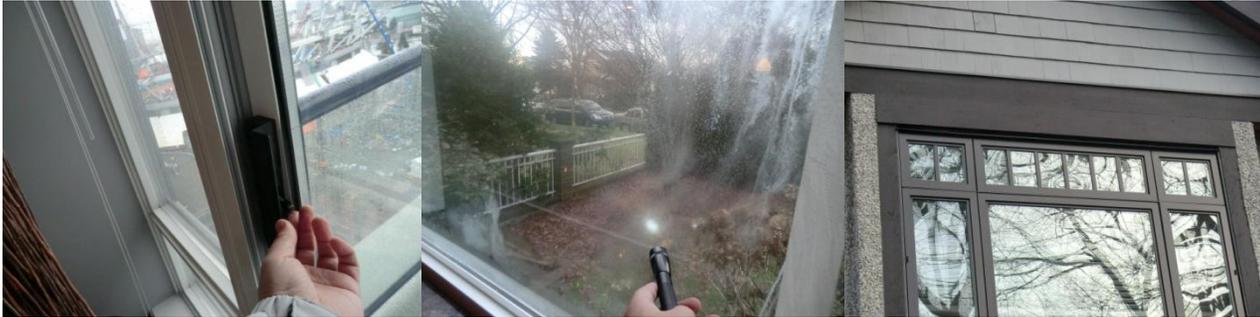
too tight or loose, unlocked in the worse scenario. Figure 1, this happened on the door to balcony of a high rise building which we inspected in downtown Vancouver a couple of weeks ago. The owner may not really care about this but no buyers will be happy to this inconvenience if they just take over the property.

It is a dilemma when there is a foggy window caused by hermetic seal leaking which is quite common during the inspection. Figure 3, this is not a major issue but annoying. Theoretically this can be fixed but not easy. The other option is to change a new one. The easy way for buyers may leave the trouble for home owner to fix. We could find water stain on window sill and frame. It is generally caused by the deflection of the window. We always ask clients to inquire home owners because they should have known more than us.

We paid more attention on window flashing when we inspect the exterior. Many old or unprofessional renovated windows do not have proper flashing which has to be inspected and caulked every year. The new buildings are much better under the new code requirement but not 100%. Figure 3 when we inspected a brand new house in Vancouver Westside, we found 2 pcs of window trims stacked on top of it. The transitions from siding to trim and from trim to window are addressed with proper flashing. But we have to question the joint of 2 trims. The water may get into the joint in our long raining season. Even though the water would not intrude into the wall structure, the trim easily got rotten. Caulking and painting are the only way to keep it in good condition.
