## Bathroom Maintenance 2

**Henry Liu CPBC 53115 Canada Association of Home and Property Inspectors of BC**

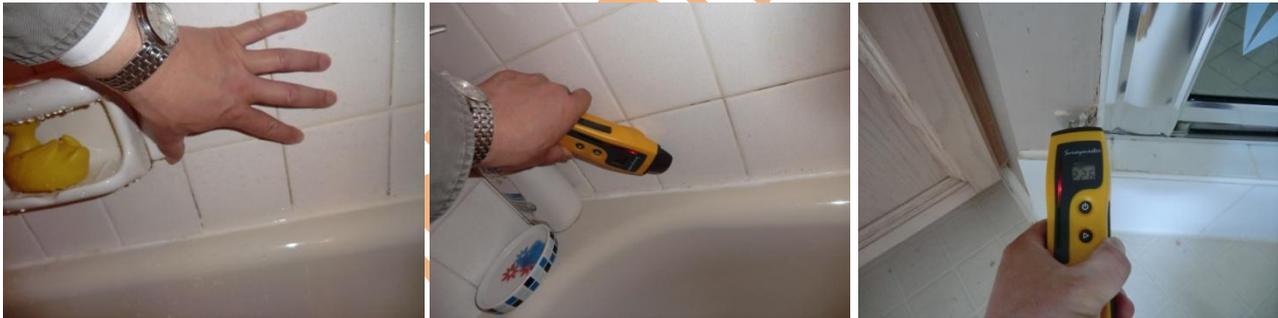
There are 2 kinds of bath shower installed; one is Acrylic of fibre glass integrated form in 1 piece and no joints which the moisture & water leaking can be avoided, also some are formed together with seams which should be checked & caulked open sections each year; the other popular shower stall is tiles installed on the wall, which the grouts & joints have to be inspected & serviced every year. If the shower enclosure cannot be cared regularly, the hidden moisture may cause the wall system wood structure rotten & lost strength. Especially condos once in the worst scenario the leaking could drip down to the lower suites which can pursue the compensation. During our inspection we physically touch & push the shower wall & floor around bath & toilets to find if any softness is over there. In addition, we all have the non-invasive moisture meter to detect the substrate but we won't only depend on the instrument. This testing could be misled by different tiles materials and wall assembly. The actual performance is objective & reliable.

Besides we reiterated the bath ventilation enforcement, it is better to swipe the water on the wall into the pan after shower in order to reduce the chance moisture intrusion to the wall. Grouting & caulking should be a regular maintenance in every summer or fall.
