The boiler heating system

Henry Liu CPBC 53115 Canada Association of Home and Property Inspectors of BC

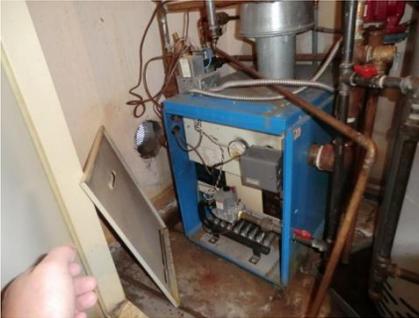
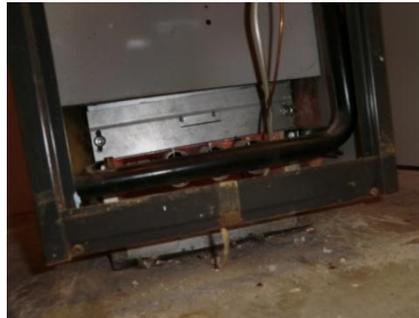
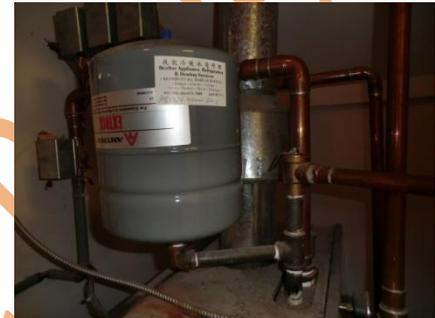
Boiler is the common residential heating system, It used the burner to heat the water in the other side of heat exchanger, which was circulated to the living space through pipe and pump. The room was warmed up either by baseboard installed under the windows or in the hall way or by the pipe buried in floor. The whole system was comprised of gas fuel delivery, exhaust, water supply and circulation as well as operation control and safety control. Clients often got confused in between boiler and water heater. Please be advised these are 2 facilities which function, application and life expectancy are quite different.

During our regular home inspection, first, we had to make sure the burner working properly, no abnormality on the flame. There were no burn around burner opening and enough refreshing combustible air supply, also the right connection of the exhaust vent. It was hard to watch the heat exchanger but not hard tell once it failed for the leaking visible. The life expectancy of boiler was about 25 years. The pressure reduce valve and backflow preventer should be in place on the water supply pipe. The former reduced normal water circulating pressure to 12-15 psi. The rear kept circulation water not to go back to and contaminate building water supply once the water supply lost its regular pressure 60 psi. In addition, the expansion tank and pressure relief valve had to be installed. They were safety control which the former offset the pressure generated from heating and the rear would open to release the pressure once it was over 30 psi. Some systems were installed air vent valves which improved heat transfer and protected water pump for air pocket. They were often leaking and rusty. Zone valves worked together with thermostats in different rooms to control the heat supply. Copper and Pex were the regular adopted heating pipe. We paid attention to Poly-B pipes. Theoretically, there was no air barrier on this pipe. The oxygen can get into the pipe can cause the metal corrosion. This was not a good installation but there were some remedy for the system. We had found some system working over 20 years with Poly-B pipe. The regular maintenance was necessary
