## Is it a leaking water tank?

Henry Liu CPBC 53115 Canada Association of Home and Property Inspectors of BC

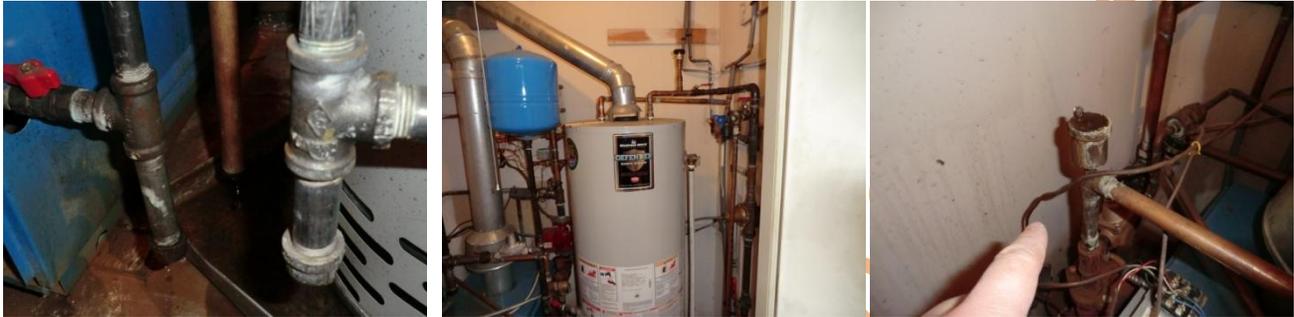
Since the initial inspection of the landscape, porch and balcony, it was verified that the house was not well maintained by this owner. A lot of work is on the way of the new owner. When we inspected hot water tank and boiler, we found the HW tank just changed in 3 years and nicely piped. The pressure relief valve was in place. It was little chance to have the tank or pipe leaking. At this moment, the adjacent boiler started running. The water dripped out from the pressure relief pipe. (Figure 1) This is unusual. Although the pressure relief valves were necessary on the 2 facilities, they are only the safety precaution control rather than the regular operation control. They should only be activated once something wrong in the operation. Consequently the work must be transferred to plumber. But we still helped analyse the reason and possible consequence which made the buyer to know before the deal.

When the boiler is running, the water expands inside the exchanger, which leads the water pressure increases in the pipe. But due to the expansion tank (figure 2) installed, the pressure is only in between of 12-25 psi. If there is water dripping from pressure relief pipe, the pressure is over 30 psi and also means the expansion tank failure is quite possible. There may have something wrong with the air vent (figure 3) as well, but rear is not a main issue. All rooms can get the heat and the pressure is back to normal when the boiler is idle. Therefore the pressure reduce valve is still effective and no piping blockage is existing. To change the expansion tank is a quick easy way to fix the trouble. If not repaired, the potential risk is: 1. the pipe blast and leakage chances are quite possible once the last protection the pressure relief valve failed; 2. The keep added fresh water comes in with oxygen which causes the corrosion of the heat exchanger. The cost of a new boiler is not cheap for the premature failure of the exchanger.

We confirmed the performance of HW tank and pointed out the reason of standing water. The client was satisfied with our service and we were happy to help solving the problems. We also suggested hiring the professional to service the boiler every year in order to keep it working longer.
