The commonly applied wall materials

Henry Liu CPBC 53115 Canada Association of Home and Property Inspectors of BC

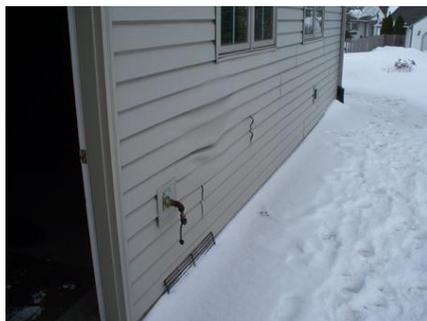
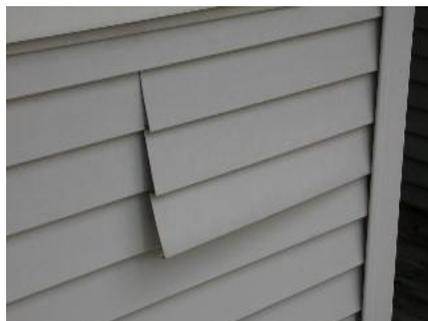
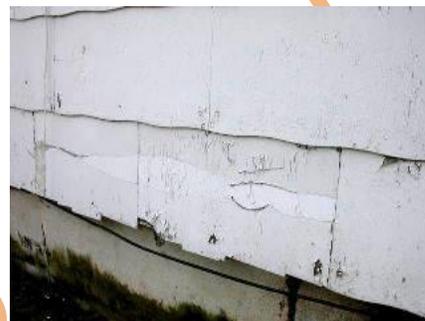
Most chances we saw the existing metal siding is aluminum board horizontally installed by overlap. It was popular between 50s and 70s due to its durability, light weight and easy installation. But it got slow down thereafter since the material cost kept going high and the high energy consumption was in the production. On the contrary, vinyl siding started taking the market since emerging in 50s because of its cost and installation, especially after improvement in 70s, which got rid of the premature failure by the attack of UV, as well as crack and deformation from mechanical impact. Theoretically it could last 40 to 60 years thereof it replaced metal siding and became the dominant wall material in 80s. The deficiency of these 2 materials is mainly related to installation. For example figure 1 the fastener is too tight to allow the siding movement by thermal expansion, which bent the board finally. Figure 2, the loose installation caused siding displacement by impact or wind. By contrast to other siding materials these 2 are easy to get mechanically damaged from bikes, ladders even the ball. Also, in a certain area exposed to UV or moisture or vegetation, the siding color fading or discoloration could happen. This could be barely restored if vinyl. Aluminum could be repainted but this is not easy.

Fiber cement siding is existing on the market over 50 years, which is as popular as vinyl and stucco for its good weather ability, ventilation, fire and decay resistance as well as paints compatibility. It could last 30-50 years and cost competitive. We can see lots of new building construction with this kind of siding. It is similar as vinyl and metal. The installation mainly decides the effectiveness and service life. For example the high quality fasteners such as hot dip nails have to be adopted. The flat head nails are supposed to flash with the board or panel. Too tight may crumbled nail holes. The nail loose or not in place could cause the siding overlapped damage by any mechanical impact which is the most weakness to be avoided figure 3. The joints between boards/panels should keep 1/8" space for movement. There are 2 theories to address joints. One is to do the caulking and painting. The other is to do the flashing under each joint. This could be simply a small piece of building paper. In terms that caulking can always open or break, the rear looks a better solution. In fact, no matter which component or structure on building, caulking is always a remedy of leaking. We prefer the entire protection through good configuration.

One more reminder, any siding should leave 6"-8" space to grade in order to avoid moisture damage & and keep it ventilated to dry fast. Once there is stain or moss/mold on walls. It could be washed by detergent or bleach solution but no power wash.
